NEW YORK STATE DEPT OF ENVIRONMENTAL CONSERVATION ALBANY F/6 13/13  
NATIONAL DAM SAFETY PROGRAM. PALMER FALLS DAM, UPPER HUDSON RIV--ETC(U)  
AUG 80 J B STETSON DACW51-79-C-0001  
NY-145 NL

REPORT DOCUMENTATION PAGE		READ INSTRUCTIONS BEFORE COMPLETING FORM
1. REPORT NUMBER	2. GOVT ACCESSION NO. AD-A093025	3. RECIPIENT'S CATALOG NUMBER
4. TITLE (and Subtitle) Phase I Inspection Report Palmer Falls Dam Upper Hudson River Basin, Saratoga & Warren Counties, NY Inventory No. 145		5. TYPE OF REPORT & PERIOD COVERED Phase I Inspection Report National Dam Safety Program

PHASE I REPORT  
NATIONAL DAM SAFETY PROGRAM

Name of Dam Palmer Falls Dam, NY145

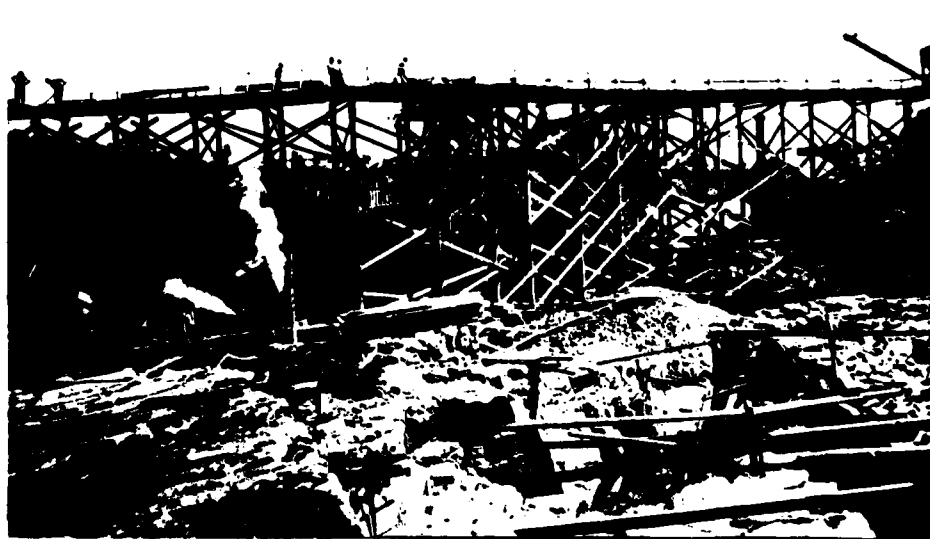
Palmer Falls Dam - July 10, 1913 - Showing Trench back of Dam
